Manhole Inspection Summary

Manhole # S27M1_002MH

Inspection ☐ Is Incomplete Rating: **2) Good**

Record Plat: **27M1** Node: **002** Status: **Found**

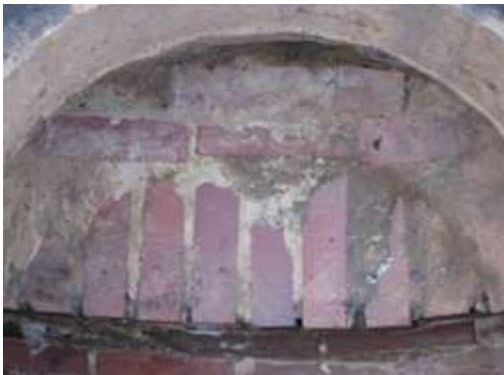
Defect 1

Bench ☒ Exists Material: **Brick** ☐ Parged
Condition: ☒ Sound ☐ Cracked ☐ Root Intrusion ☐ Deteriorated ☐ Leaks ☐ Debris

Bench

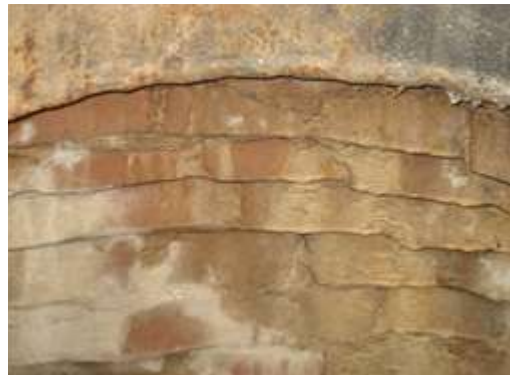
Defect 2

Chimney / Frame Adjustment ☒ Exists Material: **Brick** ☐ Parged Height: **4** (in.)
Condition: ☒ Sound ☐ Cracked ☐ Root Intrusion ☐ Loose Brick ☐ Deteriorated
Infiltration: ☐ None ☐ Joint ☐ Cracks ☐ Mortar ☐ Roots ☒ **Wall**

Corbel Material: **Brick** ☐ Parged Type: **Concentric/Eccentric**
Condition: ☒ Sound ☐ Cracked ☐ Root Intrusion ☐ Loose Brick ☐ Deteriorated
Infiltration: ☐ None ☐ Joint ☐ Cracks ☐ Mortar ☐ Roots ☒ **Wall**

Wall

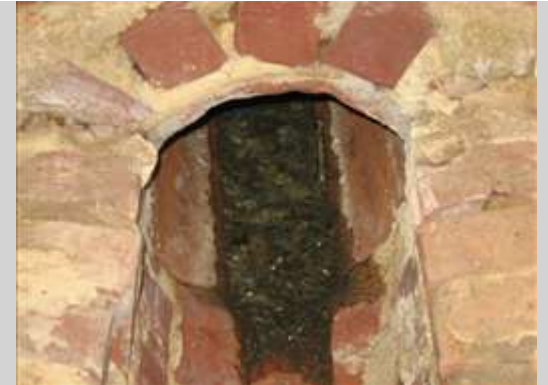
12 O'Clock Outflow

8 in. Circular Gravity Sewer
Pipe Out @ 12 O'Clock

Pipe Height: **8.4** (in.) Rod and Bar (Angled)

Pipe Material: **Clay** ☐ Pipe Lined

Invert Depth: **3.46** (ft.) Flow Characteristics: **None**

Infiltration: **None** Pipe Seal Cond: **Sound**

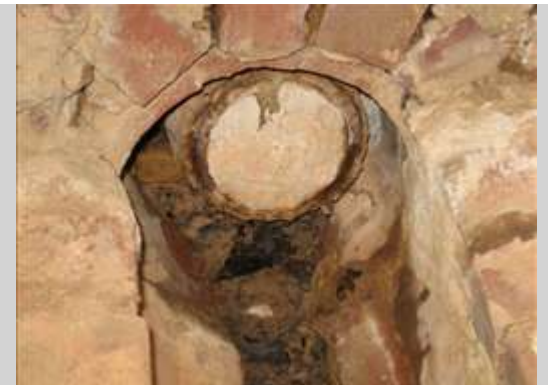
6 O'Clock Inflow

Comments **Influent pipe @ 6 O'clock sealed/abandoned.**

6 in. Circular Gravity Sewer
Pipe In @ 6 O'Clock

Pipe Height: **7.2** (in.) Rod and Bar (Angled)

Pipe Material: **Clay** ☐ Pipe Lined

Invert Depth: **2.85** (ft.) Flow Characteristics: **None**

Infiltration: **None** Pipe Seal Cond: **Sound**

Connects To: **Stub connection / abandoned**
